<b>3 MONTHS FISSURE INSPECTION</b>			<b>Page:</b> 1 of 2
				<b>Reference:</b> RI-0226-2-23
	<b>REFERENCE DOCUMENTATION:</b>			<b>Revision:</b> 0
			<b>Date:</b> 06 - 17	
<b>SAFETY REQUIREMENTS:</b>

MEASUREMENT EQUIPMENT USED (if applicable):				Date: <u>12/21/18</u>
COMMENTS: <u>Olympus Post-Derailment Visual <del>Final</del> Inspection</u>				Hours: <u>3</u>
Location: <u>SEATTLE</u>				Time: <u>7:00 AM</u>
				<b>WORK GROUP SUPERVISOR</b> Sign:
				Employee #:
				Date: / /

ANNUAL FRA FISSURES INSPECTION			Page:	1 of 2
				Reference:	RI-0223-1-23
	REFERENCE DOCUMENTATION:			Revision:	4
	IT-0212			Date:	08 - 18
SAFETY REQUIREMENTS:

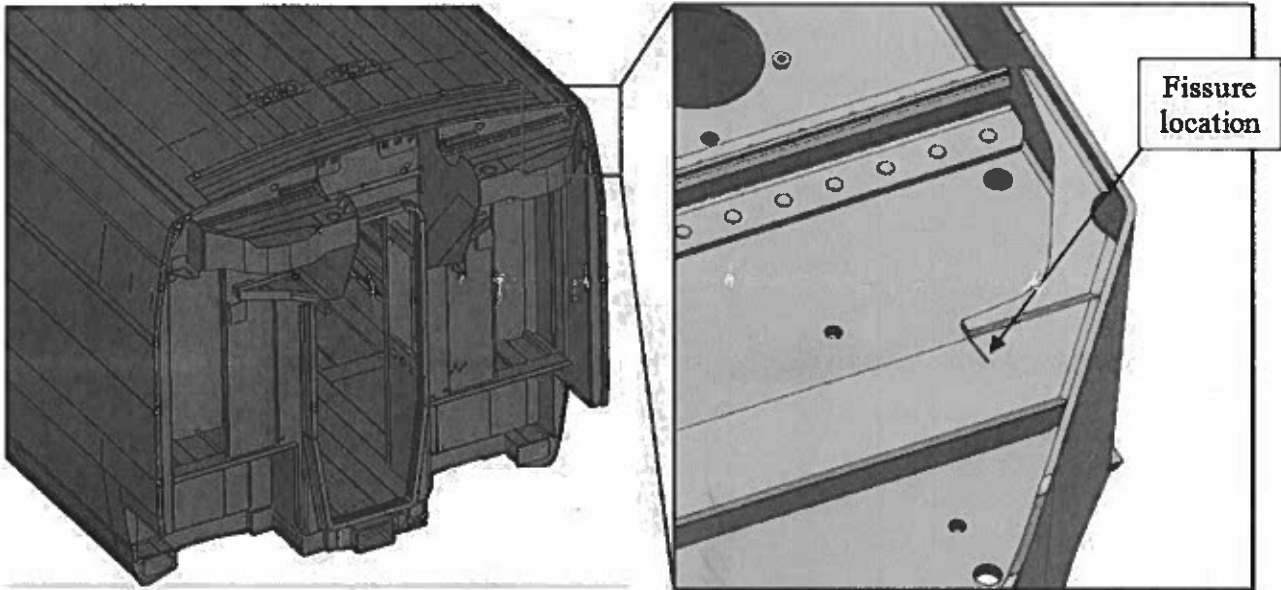
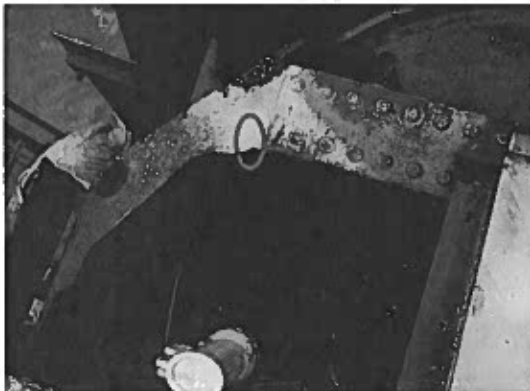
**Figure 1**

For the 3 months intervention, inspect for fissures located in the following area of all train positions:

Area	Decision	Green (mm)	Yellow (mm)	Red (mm)
Indicated in Fig.1	In case of new fissure or increase of an existing one, drill with 8 mm bit, and a stop with the T thickness, applying penetrating liquids and repair.	0	0	>0

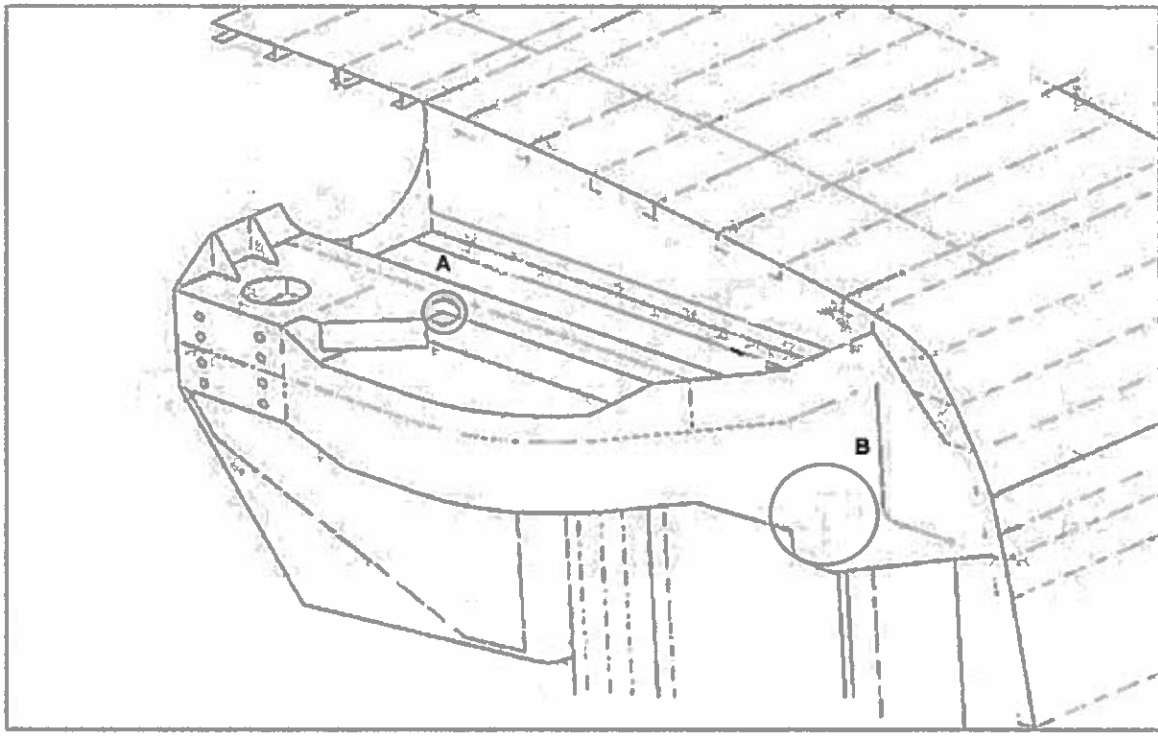
**Figure 1**

- Visual inspection of the area indicated (Figure 1 – PART A) trying to find fissures and filling in the results table indicating the car number, fissure length in mm and the decision taken, based in the table criteria.
- (20-50-01-22). Visual inspect of the area indicated (Figure 1 – PART B) trying to find fissures and filling in the results table indicating the car number, fissure length in mm and the decision taken, based in the following criteria:

Areas	Decision	Green (mm)	Yellow (mm)	Red (mm)
A	(T beam) In case that a new fissure is confirmed or increase of an existing one, drill with 6 mm bit, and a stop with the T thickness, after the repair, perform NDT (see drawing AT-46131).	0	0	>0
B	(Side holder) In case of new fissure or increase of an existing one, drill with 6 mm bit, and a stop with the side holder thickness, applying penetrating liquids and repair (see IT-0212).	0	0	>0
